Technical Memorandum 7-58

A DYNAMIC HUMAN ENGINEERING EVALUATION
OF THE ARMORED
PERSONNEL CARRIERS T113 & T117

August 1958

HUMAN ENGINEERING LABORATORIES

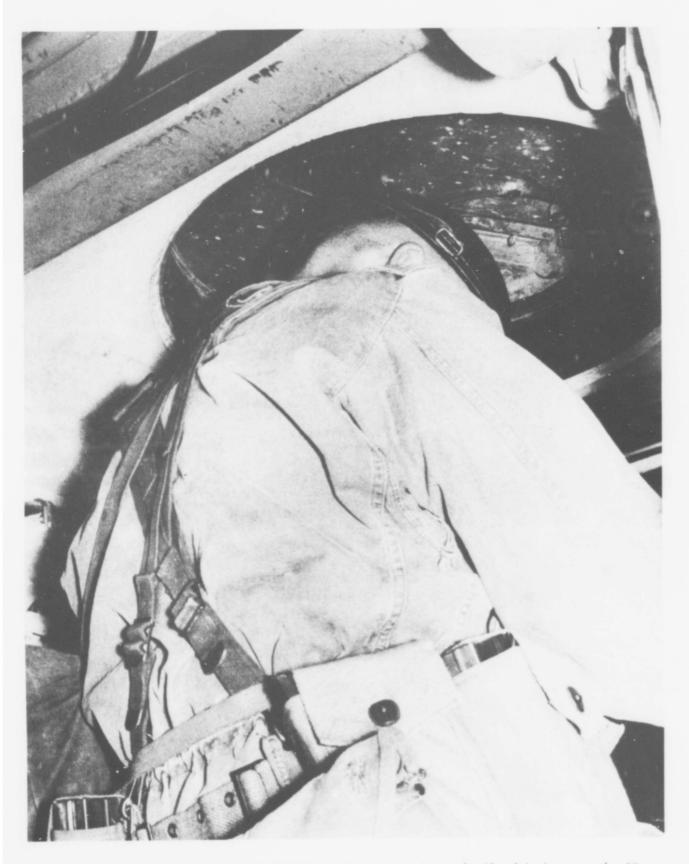
- a. A driver 5' 4" was too short to operate the accelerator without becoming very fatigued when seated in the unbuttoned position. A man 6' 1" was too tall to sit in the driver's seat with a helmet in the buttoned position (Figs. 2 & 3). For further information see TM 10-57.

FIG 2. Driver in the "up-position" stretching for the foot pedals.

$FIG \ 3. \ A tall \ driver \ in \ the \ "down-position" \ with \ full \ field \ equipment \ cannot \ sit \ properly \ without \ being \ in \ a \ cramped \ position.$

- a. In order to give the tall man some head clearance in the buttoned position, the commander and driver's hatches should be dome-shaped. Also the accelerator should be designed to allow the short man to place his entire foot on the pedal, not just the tip of his toe.

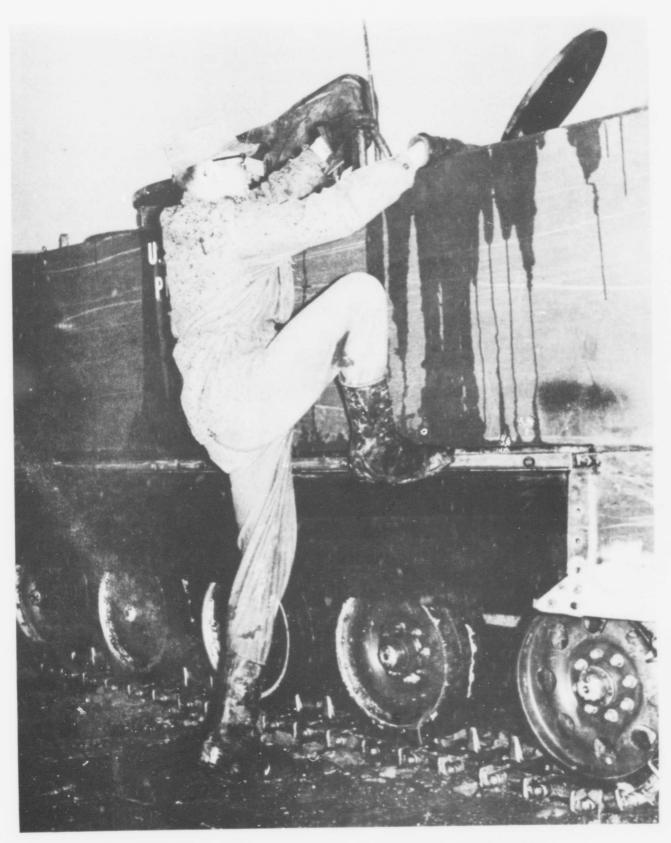
- b. There was insufficient padding located around the driver's and commander's periscopes.
 - c. It was difficult for the drivers to mount the vehicles (Fig. 4).

FIG 4. Driver taking his first step to climb aboard the vehicle. Note the stretch.

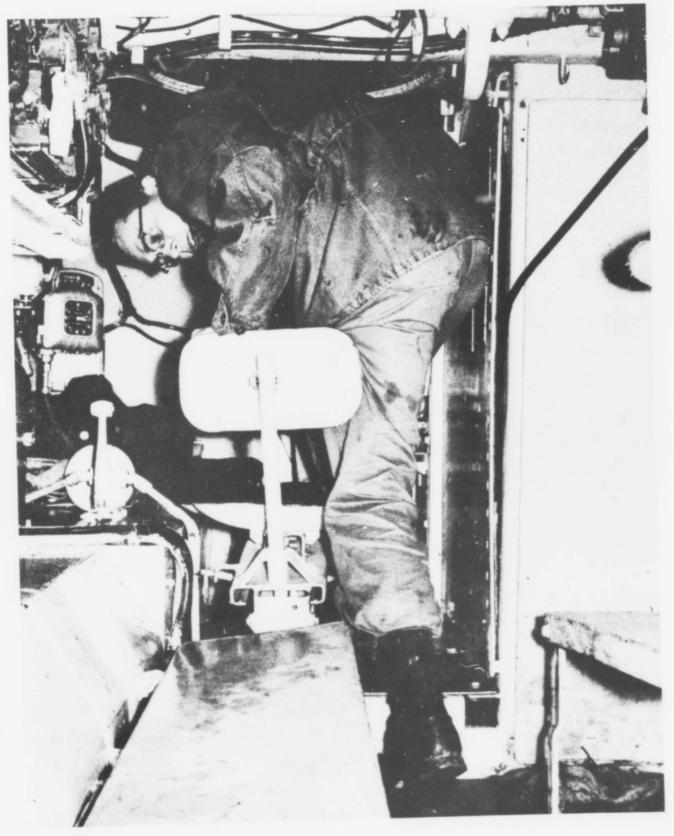
- d. The driver must leave the vehicle, climb to the top, and open a hatch to check the transmission oil.
- e. The driver and commander had difficulty entering and leaving their seats (Fig. 5).

FIG 5. Driver struggling to get seated.

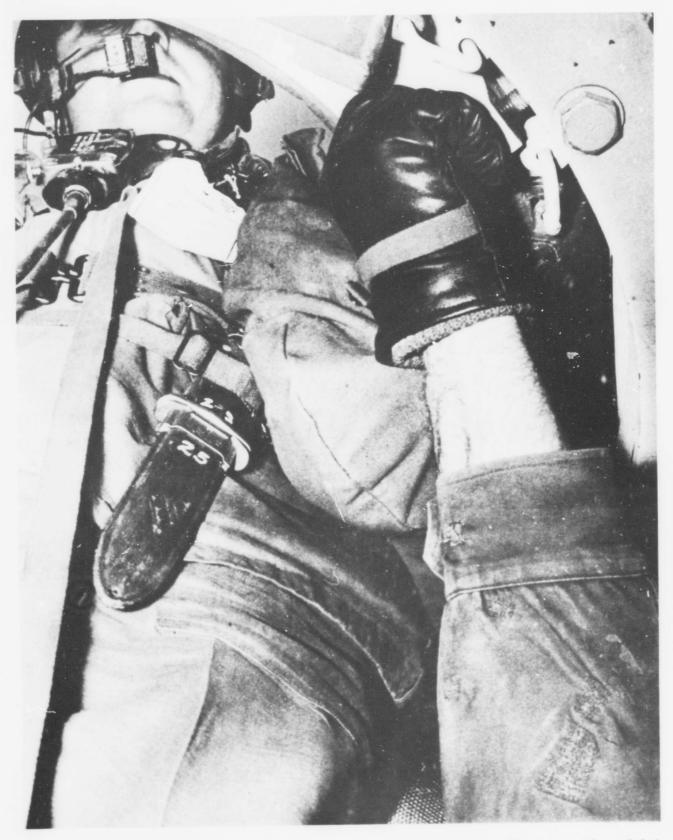
FIG 7. While riding over rough terrain, the Commander tried to tighten the cupola. After some delay he located the cupola lock. Due to his unfamiliarity with the mechanics of the cupola lock, he unscrewed the lock. This picture shows a squad member finally coming to his aid.

- g. The T-shaped screw lock, which permits the commander to turn his cupola, should be located in the 'up' position so that it can be easily reached while wearing full field gear. To prevent incorrect control movement, a lever-operated friction lock is suggested.

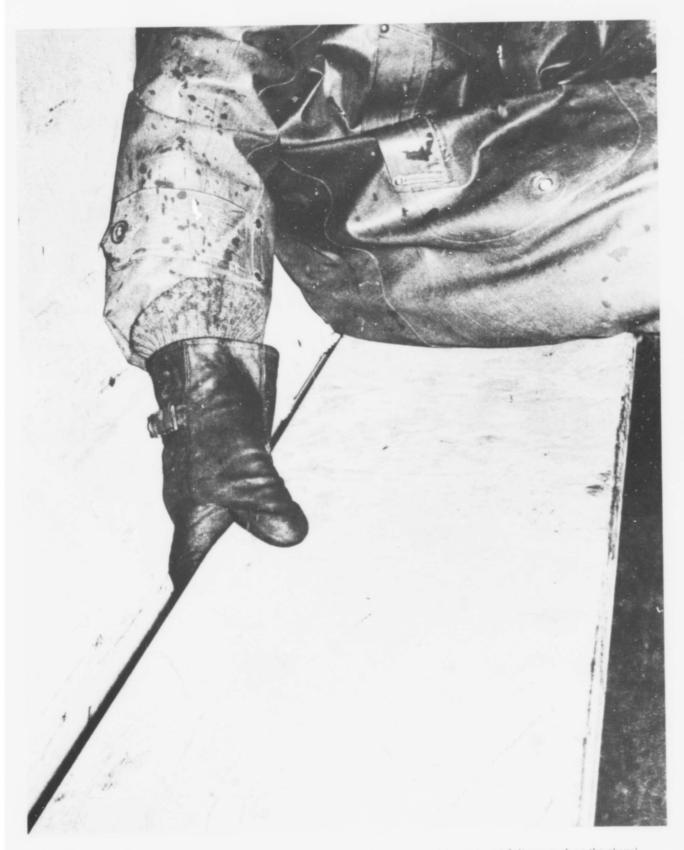
- k. There was insufficient room between the top of the commander's head and his hatch when he was wearing a helmet.
- 1. Shovel handles and other personal combat equipment were caught between the bench and walls of the test vehicles (Fig. 8).

FIG~8.~~ The~space~between~the~bench~and~the~wall~in~the~personnel~compartment~is~apt~to~catch~items~such~as~the~shovel.

- i. The bench seats should fit flush to the wall of the vehicle to prevent shovel handles and other equipment being caught, thereby preventing easy egress for the squad members.

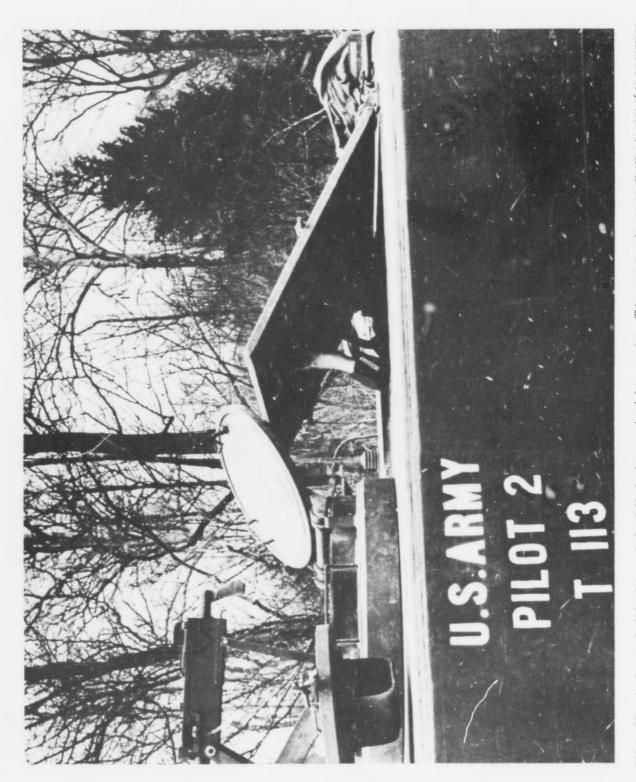
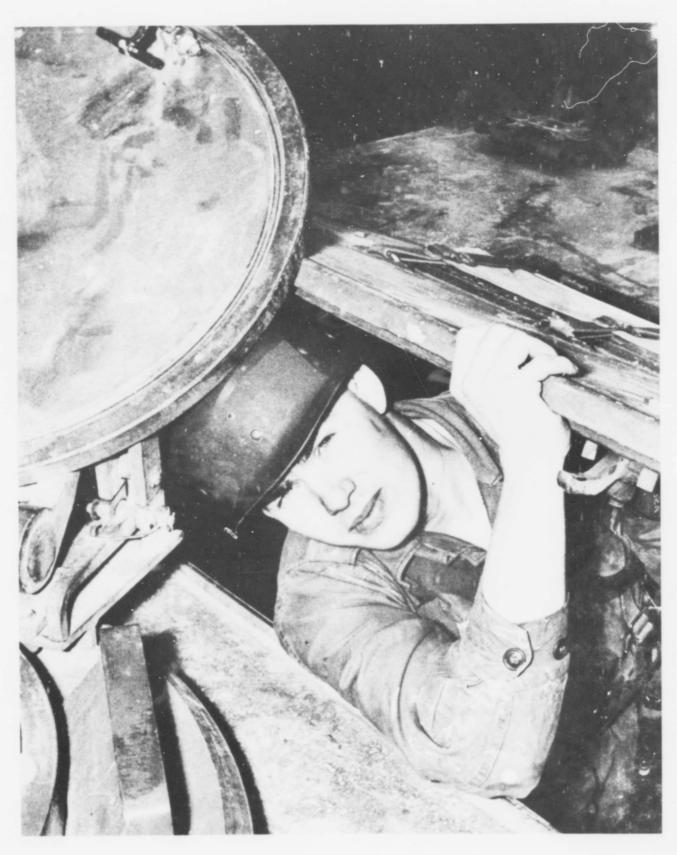
- m. The cargo hatch cannot be opened while the commander's hatch is open (Figs. 9 & 10).

FIG 9. When the Commander's hatch is up the hatch blocks the cargo hatch from opening. This presents a dangerous situation in case of an emergency.

FIG 10. Another scene of the condition shown in FIG 9.

- j. In the event of an emergency such as sinking, fire, or blocking of the ramp door, the cargo hatch should be able to be used as an escape hatch. The current design of the commander's hatch in the open position prevents this.

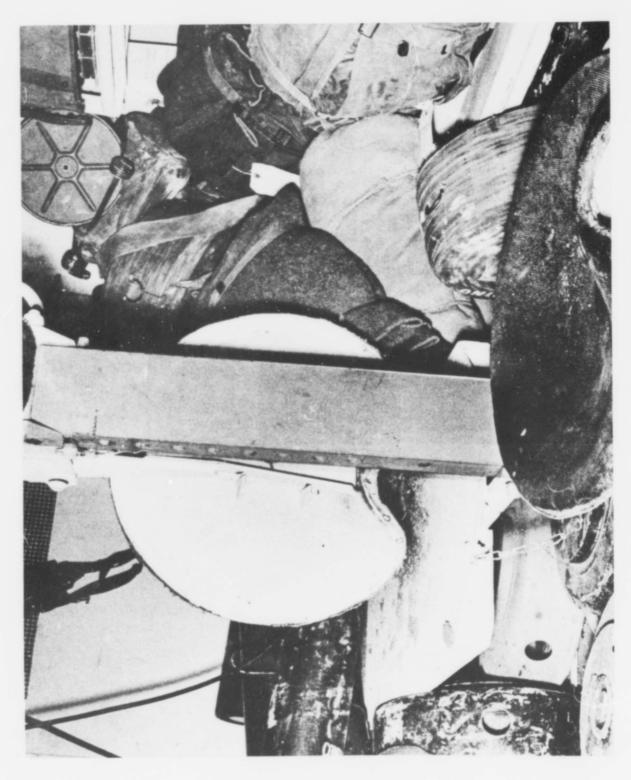
- n. There was no provision for storing and securing equipment within the vehicle and, as a result, it was scattered throughout the vehicle while traveling cross-country (Fig. 11).

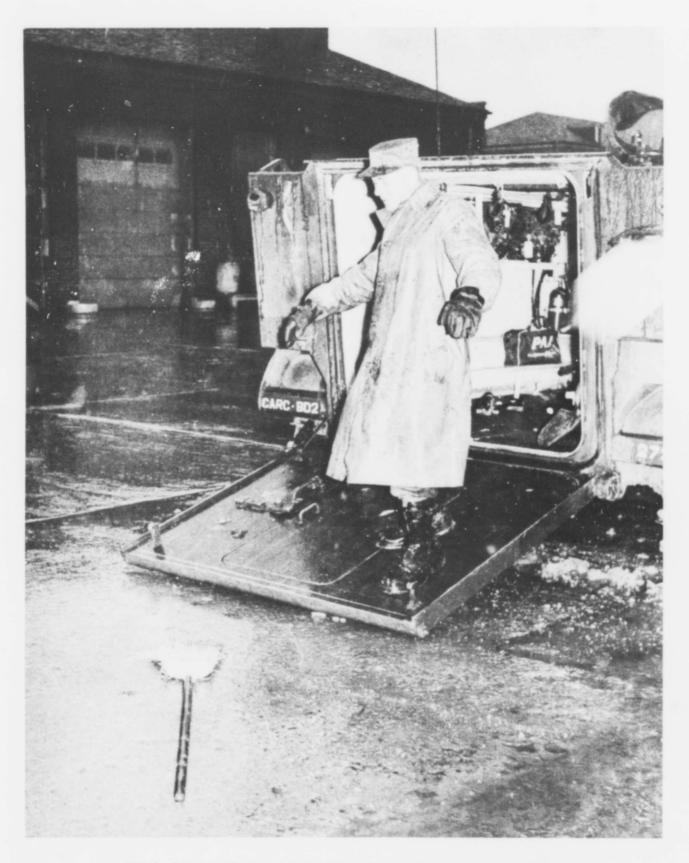
- o. The squad members were frequently thrown about unexpectedly when the vehicle encountered rough terrain or when the driver "braked" suddenly.
- p. Men slipped on the ramp and dropped equipment when dismounting. This condition was aggravated when the ramp was wet and muddy (Fig. 12).

FIG 12. Soldier skidding on a wet ramp without any non-skid coating or horizontal bars.

- m. Rungs similar to those found on the M59 ramp should be installed on the T113 and T117 ramps to prevent slipping (Fig. 16).
- n. The feasibility of redesigning the floor plates so that the area below could be utilized for storage space should be studied.

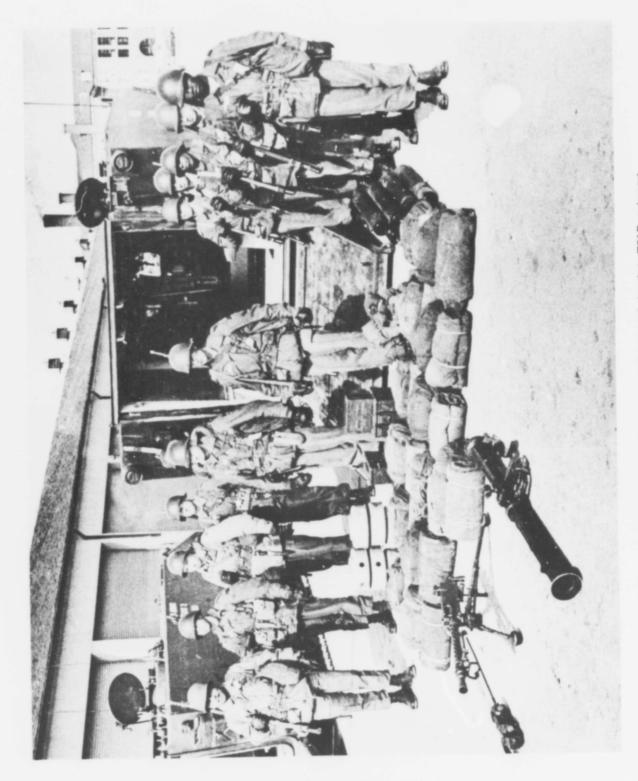
- q. There was insufficient storage space for OVM and squad equipment (Fig. 13).
- r. The radio channel on which the vehicle commander was receiving his orders was inadvertently changed by a crew member who brushed against the controls (Fig. 14).

FIG 13. Vehicle shown with its full complement of personnel plus their TO&E equipment.

- k. Racks, straps, and labels for all OVM, and redesign of current dead space, should be incorporated for better equipment stowage (Fig. 13).
- 1. The installation of a red blinker light in a conspicuous position within the personnel compartment, which could be operated by the driver, is advised. This would allow the driver to signal the crew when rough or hazardous terrain is to be encountered. The crew in turn would be able to prepare for pitching or braking movements.

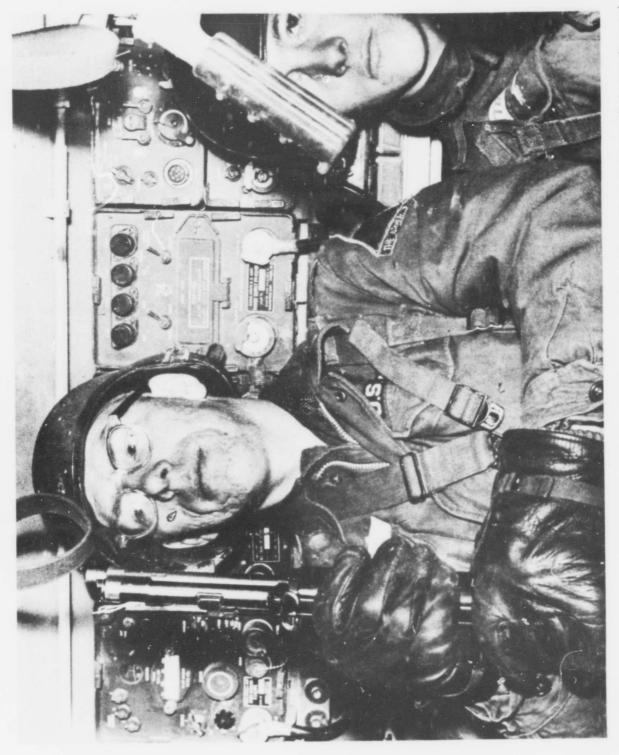
FIG 14. The soldier seated directly in front of the radio, blocks the radio controls from the Commander, and his helmet frequently disrupts the controls.

- e. A "U"-shaped hand grip placed on the wall in front of the commander would provide him with a means of bracing himself in the buttoned position.
- f. The radio should be made more accessible to the commander by relocation or some means of remote control. The radio controls should have locking qualities to prevent inadvertent movement by crew members. Rounding the edge of the radio case would prevent the possibility of injury to personnel.

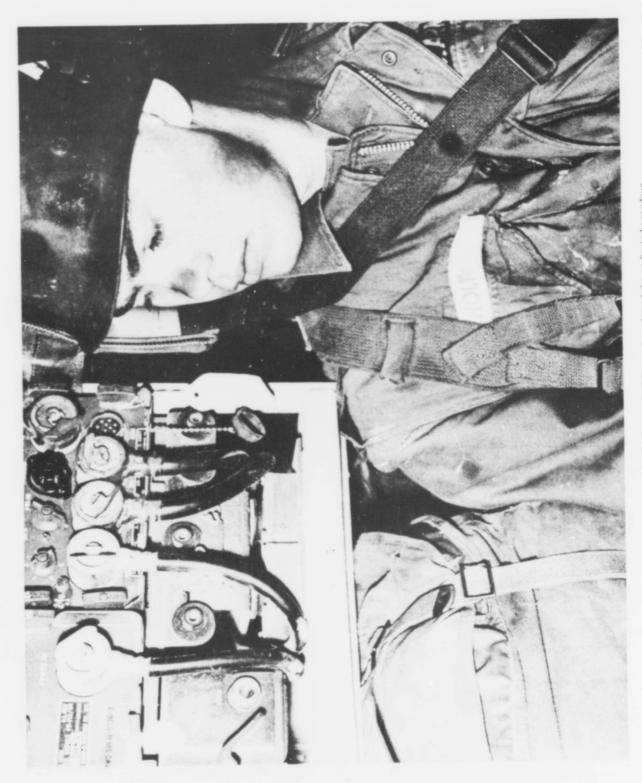
- s. The corner of the radio jutted into the shoulders of the men sitting next to it (Fig. 15).
- t. The squad leader had difficulty hearing the commander's orders and was unable to communicate these orders to the squad while the vehicle was moving.

FIG 15. The proximity of the soldier's shoulder to the edge of the radio is hazardous.
